### Evaluating permeability and groutability of Souk Tleta dam site based on Lugeon tests, RQD, SPI and trial grouting

This study is conducted mainly to evaluate the permeability and the groutability at Souk Tleta dam site. It is an embankment dam with a height of 95 m and a crest length of 200m located in the Tizi-Ouzou province in Northern Algeria. The foundation of the dam consists of thick deposits of pervious alluvium of about 21 m and Burdigalian sandstone formations. The main problem of this dam is that the bedding plains of Burdigalian sandstone in the dam site are parallel to the flow direction. To conduct this study, permeability of formations is evaluated by Lugeon test and secondary permeability index. Rock quality is evaluated by geological assessment and RQD values. Results indicate that the overall permeability of the foundation rock mass before trial grouting is more than 54% of the Lugeon tests is high and requires treatment. To investigate effect of grouting in reducing permeability of rock mass and to evaluate the grout take in rock masses, two trial grouting programs are carried out on dam foundation and left abutment of dam site up to maximum depths of 70 m an

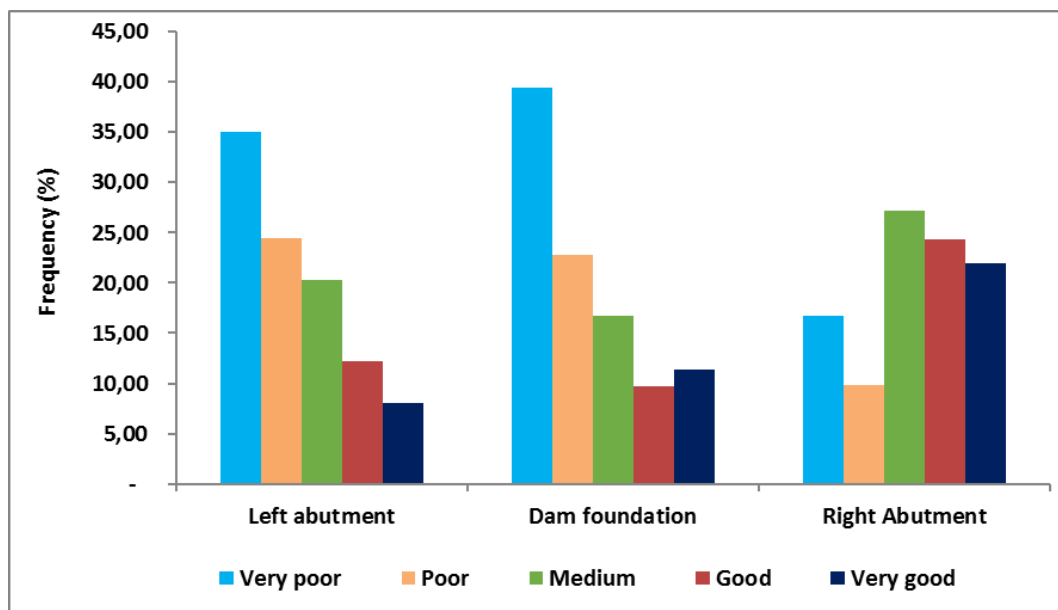
Fig. 5 illustrates the distribution of mean RQD records in different parts of the Souk Tleta dam site. The rock quality assessment of the dam site shows that the rock quality of the right abutment is remarkably higher in comparison with the quality of the dam foundation and the left abutment rock formations. As presented in Fig.5, most of the RQD values in left abutment and dam foundation are  $25 < RQD \leq 50$  and  $RQD < 25\%$  which indicate poor and very poor quality. In contrary, this condition is different in right abutment because most RQD values are  $50 < RQD \leq 75$ ,  $75 < RQD \leq 90$  and  $RQD > 90$  which indicate medium, good and very good quality, respectively.

Fig. 5 – Variation in average RQD records with rock quality and position of borehole study

In this side, approximately 22% of the sections have an RQD more than 90 and 17% have an RQD less than 25, which places them respectively, in the “Very Good” and “Very Poor” classes (Fig.5). In addition, 54% of the sections are present in a rock with “Very Low” permeability, which indicates that there is no need for ground treatment (Fig. 7). Moreover, 23% of the sections are present in areas with “Low” permeability and approximately 23% show “Medium” to “High” permeability, especially, in BH105. In general, in this abutment, except for BH105, permeability decreased with increasing depth. The test sections with high permeability (such as in section 46–50 m in BH105) showed a sub-vertical fracture and altered sandstone was present. In depth (14–17 m and 27–30 m), a high permeability should be noted, as they indicated the presence of numerous joints in sandstone formation.

Figure 7 shows that 60% of the Lugeon results are very low and 25% are low i.e. 85% of permeability results are from very low to low. In the other hand figure 5 shows that 39% of very poor quality and 23% of poor quality, i.e. 62% of RQD results are from very poor to poor quality. This can be attributed to plains of sandstone formation in riverbed that are parallel to flow direction of the river. With time and under high water pressure, preferential infiltration pathways can be created in sandstone formation and weaken its stability. Fifteen percent of tested sections show medium permeability (Fig. 7). These high Lugeon values are caused by alteration of sandstone formation in the riverbed.

As presented in Fig. 5, most of the RQD values along the dam axis were <50, indicating the poor quality of rock masses. The rock quality of right abutment was found to be slightly higher in comparison to the quality of the river bed foundation and left abutment.

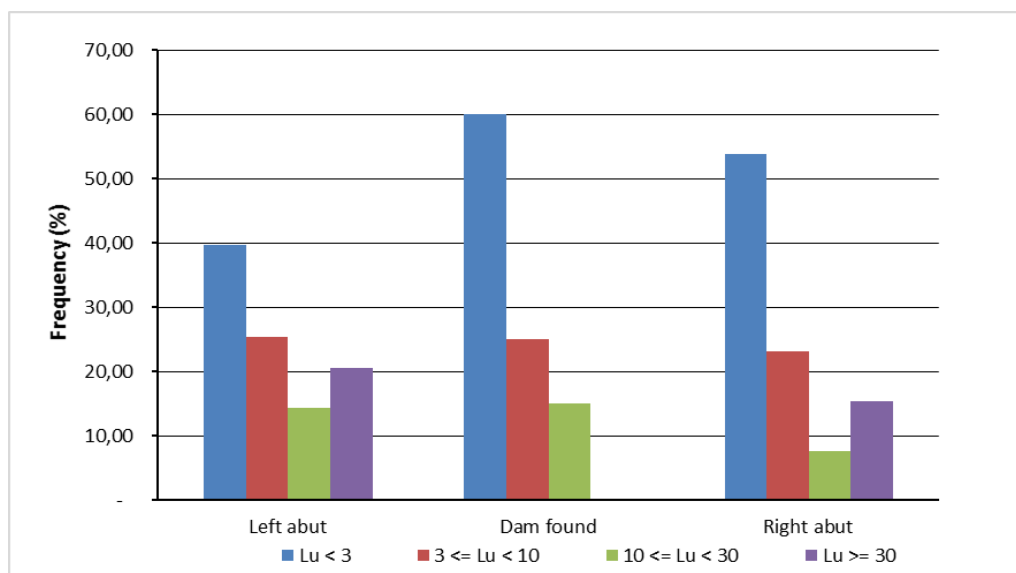
*Fig. 7 – Permeability of rock masses (Lugeon values)*

In a majority of the tests conducted using a WPT in this abutment, there is an accurate correlation between the rock mass quality defined in the RQD results and permeability (Fig. 5 and Fig. 7). Moreover, when the Lu values were gauged, almost 40% of the borehole sections in the left abutment indicated Lu values less than 3. The higher values, 14% and 21% respectively, indicate the characteristics medium permeable ( $10 \leq Lu < 30$ ) and high permeable ( $Lu > 30$ ), which may be related to the rate of weathering of the sandstone unit and its lithology, as well as the weak cementation of the conglomerate rock unit.

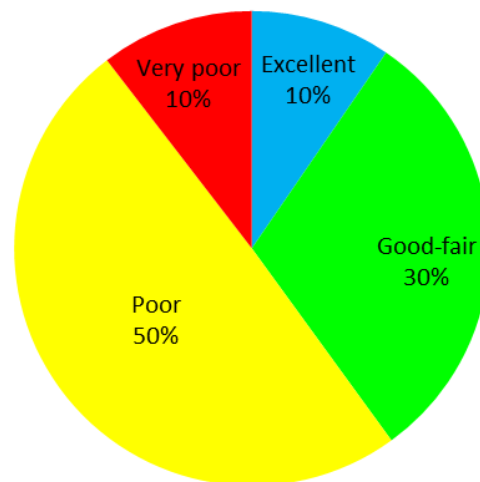
**Fig. 9 – SPI classification at left bank of Souk Tleta dam foundation**

Among the four classes (Table 3), and based on observation of the foundation mapping (Fig. 8 and Fig. 9), it is noticed that left abutment rock mass is dominated by large portion (50%) of poor rock quality (class C) where ground treatment would be required. Ten percent (10%) of results are situated in zone of extensive ground treatment as they categorize as very poor quality (class D).

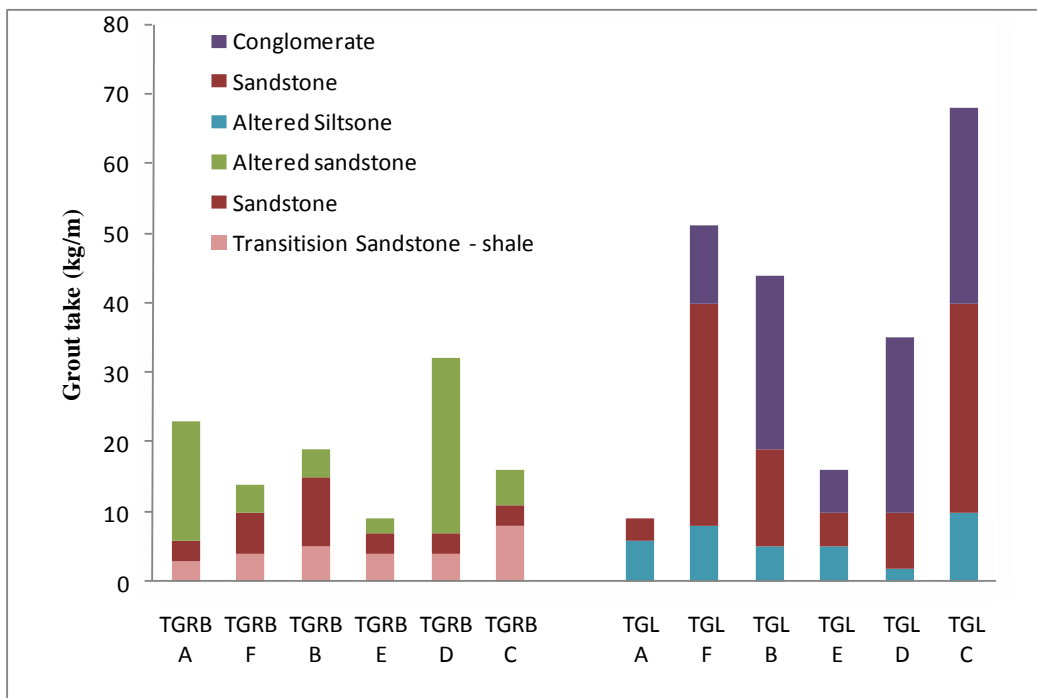
Fig. 11 – Average grout take by panel and lithofacies in riverbed and left abutment

Table 5 and Fig. 11 presents the grout take results by lithofacies units obtained for each borehole of the two trial panels. As illustrated by the figure, the grout takes were not reduced for all boreholes—A, F, B, and E to D and C—in the river bed and the left abutment. Grout takes in left abutment are higher than that of river bed. High grout take is generally observed in intervals that exhibit medium to high permeability. Grout take variation generally follows the Lugeon trend. The average grout takes were found to be higher in the conglomerate (TGL) formation than in the other rock types.

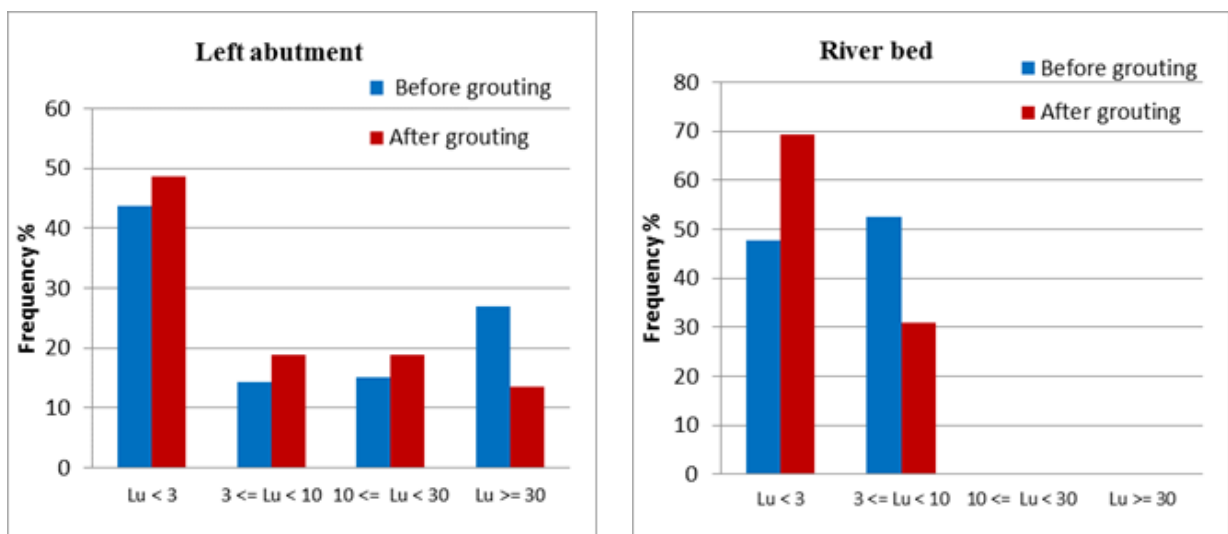
Fig. 12 – Lugeon frequency distribution before and after grouting in riverbed and left abutment

Water pressure tests were conducted on the check holes to obtain more information on the permeability of the grouted formations in trial panels and inspect the groutability success, and the corresponding results are presented in Fig. 12.

The overlapping curtain can be controlled from the vertical orientation of the check holes. It was observed after comparing the permeability results before and after grouting (Fig. 12) that the permeability of TGRB was reduced (69% frequency was less than 3 Lu rather than 47% before grouting, and a reduction of 21% frequency for permeability values between 3 and 10 Lu was observed).
