INTERNATIONAL JOURNAL OF RESEARCH - GRANTHAALAYAH

A MONITORING SYSTEM FOR PETROLEUM PIPELINE VANDALISM IN THE NIGER DELTA REGION OF NIGERIA

Petroleum pipeline vandalism has, over the years, become a torn in the flesh of successive administrations in Nigeria as the nation losses 12 billion dollars yearly to pipeline vandalism related issues. There is an urgent need to permanently address the rising scourge in the nation. In this study, an approach for synthesizing a monitoring system to curtain pipeline vandalism in the Niger Delta Region of Nigeria is presented. The design was done in stages starting with the power supply subsystem and culminates in the simulation of the whole subsystems to give the overall monitoring system. The simulation of the subsystems was done using the procedural programming application Proteus 8. Most of the components used in the design of each sub systems was according to design specifications from data book with alternatives used in cases where they are unavailable. The overall system was tested to perform the required task of monitoring pipelines. It is found that the overall system is able to monitor petroleum pipelines and reduce acts of vandalism

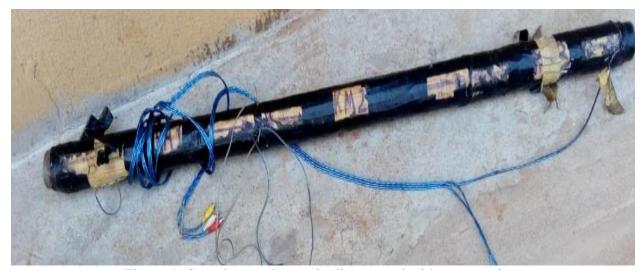
The Control room or base station has a central server which has been programmed to send signals to various terminals to alert them of any intrusion. This is done with the aid of wiring sensors that have been wound round pipelines in remote locations as shown in Fig. 1 below.

Figure 1: Sample petroleum pipeline coated with sensor wires

The alarm is set to go off if trespassers or vandals go beyond a certain limit nearer to the pipeline. The sensors wound round the pipelines acts as the actuator to trigger the alarm at the control room or base station once it detects the presence of people or animals. Light Dependent Resistors (LDR) was used in consonant with other resistors in the design so as to make it work properly at night. The designed circuit is put in a box and placed in any network provider mask area where it will have the best of network at all times for quick and uninterrupted transmission of information to the control room for action in cases of intrusion. The overall block diagram of the designed system is as shown in Fig.2 below

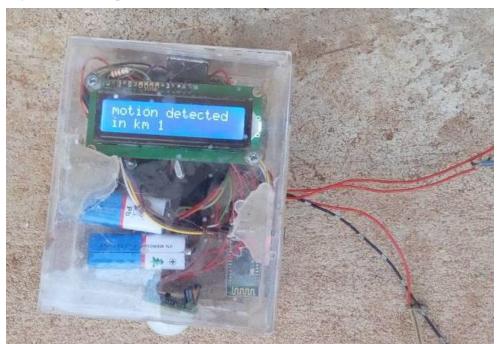
Figure 7: Complete designed prototype packaged in a case

vandalized pipeline while Fig. 7 shows a prototype of the designed petroleum pipeline monitoring system put in a casing and placed at the base station

The system produced results that met the system specifications and the entire system objectives. The indicator and the alarm continue to indicate a breakage at the sensor until it is noticed at the control room.
