**Research Article**

**Clay and organic matter applications on the coarse quartz tailing material and the sorghum growth on the post tin mining at Bangka Island**

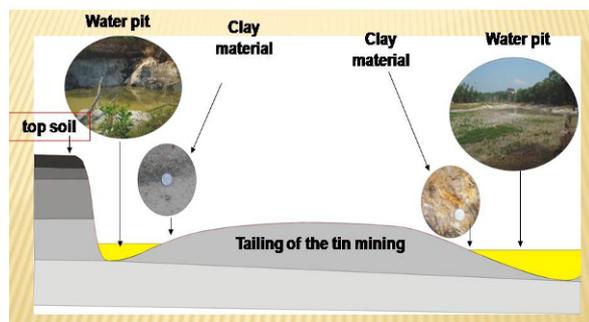
Figure 1. The land surface on the post tin-mining activity

In the process of extraction tin with a spray method can leave a coarse material deposited directly on the site. Then the fine-sized material is slowly deposited gradually in accordance with the size of the material. With the size of very fine material, forming a layer

which sediment is impermeable to water. In the advance of small basin land as a result of excavation until the tin ore is found then the basin becomes water reserve a place called the pit water (Figure 1). The presence of the pit water could potentially be used as irrigation water in reclamation by re-vegetation when the plant needs water.

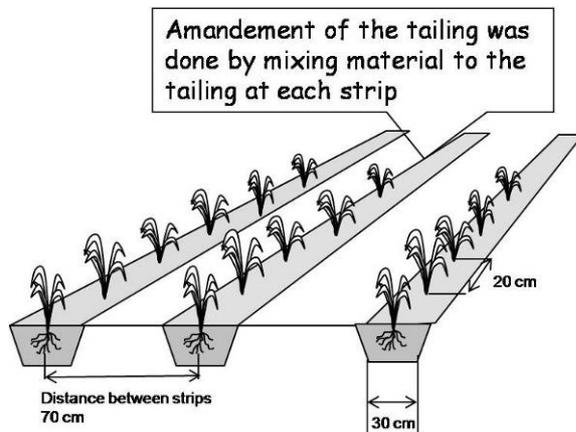
Figure 2. Model of the reclamation on the tailing of the post tin-mined land

The experiment was set by constructing the planting strips with distance of 70 cm. In order to minimize the requirements of the amelioration materials, the amelioration was done by mixing it with the tailing only on the strips of the planting at 30 cm in width and depth.

The combination of tailings, clay and organic matter alone could not suffice and provided good conditions for plant growth. This was because the clay used did not have enough nutrients, and this was shown by the growth of sorghum plants were stunted. In this study the application of amendments made in the form of strip so that the costs used to improve tailing were low (Figure 2).

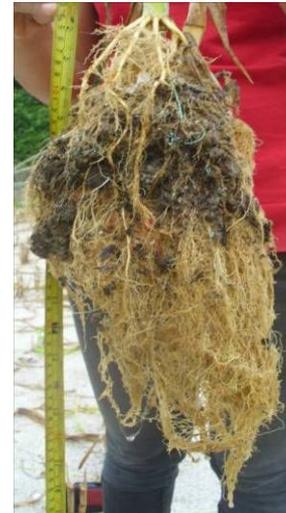
Figure 3. The roots of the cultivated sorghum at the treatment of the clay + OM + NPK.

The present study showed that sorghum plants can grow well in media with acidity levels and also a high percentage of exchangeable Al. This was shown by morphological roots that grow well (Figure 3), so that plant roots can grow well without showing any

Figure 3 also showed that root growth was in the zone of tailing that had been improved by the additions of clay and organic matter. This treatment could enhance the media's ability to absorb water and provide adequately for sorghum plants, especially when the media did not receive water supply. Management of sandy soils was based on the soil characteristics and crop suitability to achieve sustainable (Zhao et al., 2005). In addition, nutrients were added in this study, that were nitrogen, phosphorus and potassium, could be stored and then available in the exchange complex. As for that was not added clay could be made possible many of these elements were leached. This was indicated by stunted growth in other two treatments of NPK + OM and clay + OM, and moreover those without treatment (control) plants can only survive within a month.

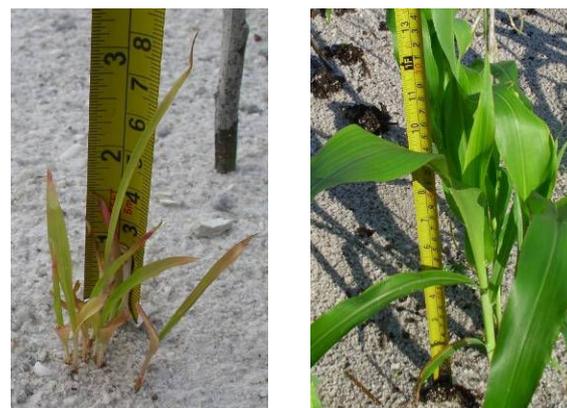
Figure 4. The colour of sorghum leaves at control (left) and the treatment of clay + OM + NPK (right) after three weeks.

There was a very clear distinction between the treatments with complete and control on sorghum leaf colour (Figure 4). In the control treatment, leaves showed yellowish green in colour and then gradually became red and leaf tip showed a purplish red colour. The leaf colour might indicate that the control treatment there was deficiency of macro elements of N, P and K. while for the other three treatments showed the adequacy of the third element of the macro nutrients. Sorghum was reported as very responsive plant to N and P nutrients (Booker et al., 2007). The change of leaf colour is caused by a deficiency of nitrogen element that few of  $\text{NO}_3^-$  and  $\text{NH}_4^+$  are transported through the phloem, resulting in discolouration and eventually chlorotic. Sorghum

Visible symptoms are chlorosis on young leaves which occur starting from the tip of the leaf. Chlorosis begins in young leaves because of nature the nitrogen that is not easily transported from older leaves. Low mobility probably occurs because one of the major protein-containing leaf nitrogen is the Rubisco photosynthetic enzymes. When the enzyme was hydrolyzed by proteinase, photosynthetic activity would go down and this is a process of self-destruction. In case of prolonged deficient, chlorotic leaf also happen to the bones so that all parts of the pale-coloured leaf. Which causes stunted growth of leaves inhibited the ability of photosynthesis.

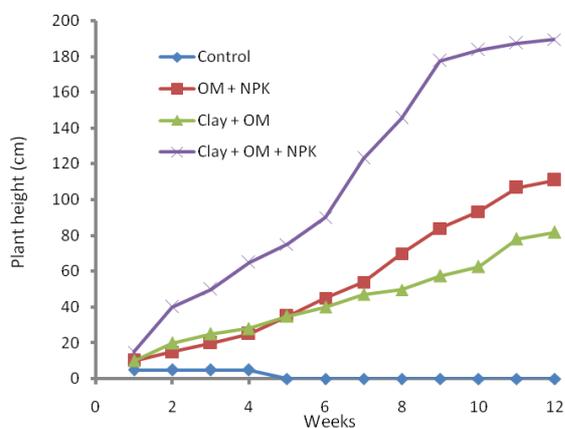
Figure 5. Plant height of the sorghum that cultivated on the tailing after reclamation

Figure 5 shows a very obvious difference between the height of plants that received the treatment and control. Sorghum plant height increases linearly and significant up to 13-week-old plants on tailings that were given a mixture of clay + NPK + OM. This was supposed due to the addition of clay media structures originally single grain to be structured so might hold water longer to suffice the needs of plants. In addition former tin mine tailing was very poor in nutrients can be improved by the addition of organic matter (OM) and NPK fertilizers so nutrients become available.
