**THE EFFECT OF GULLY EROSION ON THE FORMATION OF
SCREES AND ROCK FALLS IN THE SECTOR OF ZABALA,
PICHINCHA PROVINCE, ECUADOR**

Summary. *A study was conducted on the effect of the number and length of gullies on the development of rock falls and screes on the eastern slope near the city of Quito in the Equatorial Andes. It has been established that gullies with a length of more than 400 m have the most significant effect on the formation of rock falls and screes at the foot of the slope. The total number of gullies is not a significant factor in the development of these geomorphological processes.*

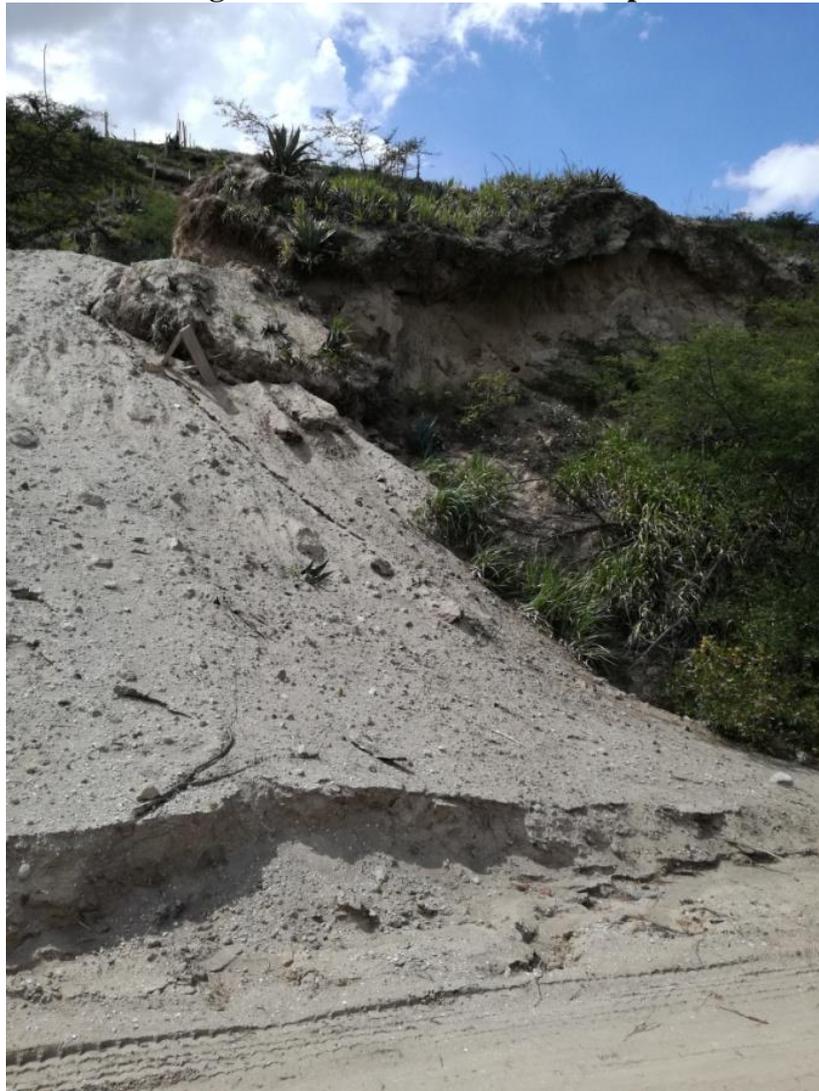
Fig. 1. Scree at the foot of the slope

A comparison was made of the number of rock falls and scree on the studied areas. This paper took into account the scree and rock falls in the lower part of the slope, which are important in terms of the impact on infrastructure. In particular, the paper has an assessment of the potential risk of blocking a local road at the foot of the slope. Figure shows a scree at the foot of the slope.
