## International Scientific Journal Theoretical & Applied Science

N. Crăciun

## EFFECTS OF THE THERMAL RISK FACTORS ON THE STATIC STRENGTH OF THE STRAP COMPONENTS

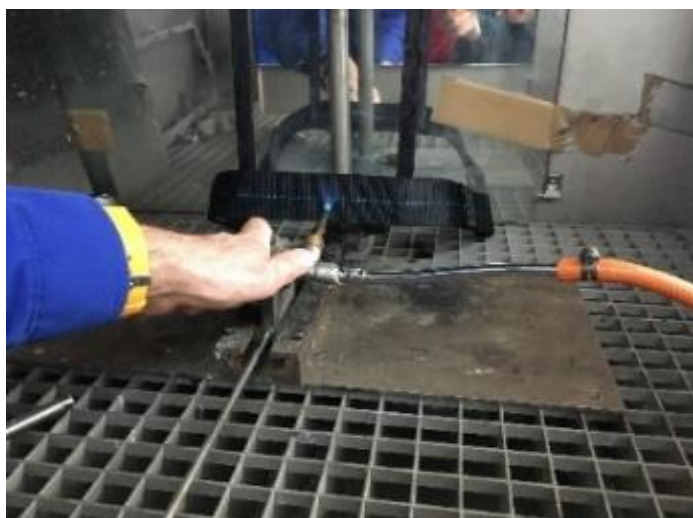
- Exposure to flame for 10 s: The method consisted of exposing the samples to the flame of a burner specified in EN ISO 15025:2017 [9] for 10 s. The burner flame in the horizontal standby position was adjusted to  $(25 \pm 2)$  mm, the distance measured from the end of the burner to the extreme point of the yellow part of the flame. During the test the burner was positioned perpendicular to the test sample at a distance of  $(17 \pm 1)$  mm measured between the end of the burner and the surface of the strap (see figure -1).

Figure 1 - Flame exposure system

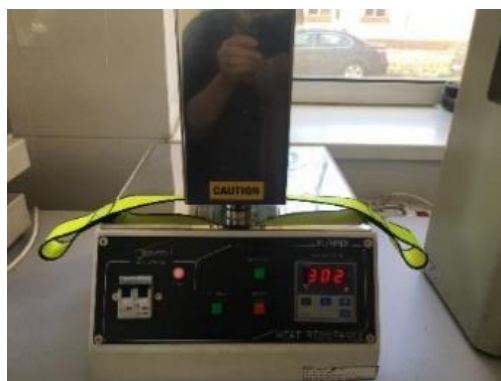
- Exposure to contact heat for 60 s at  $300 ^\circ\text{C}$  [4, p. 1669]. The equipment used was as described in

section 8.7/EN ISO 20344 [10, p. 71] pg.71 (see figure - 2).

Figure 2 - Apparatus for testing the contact heat resistance

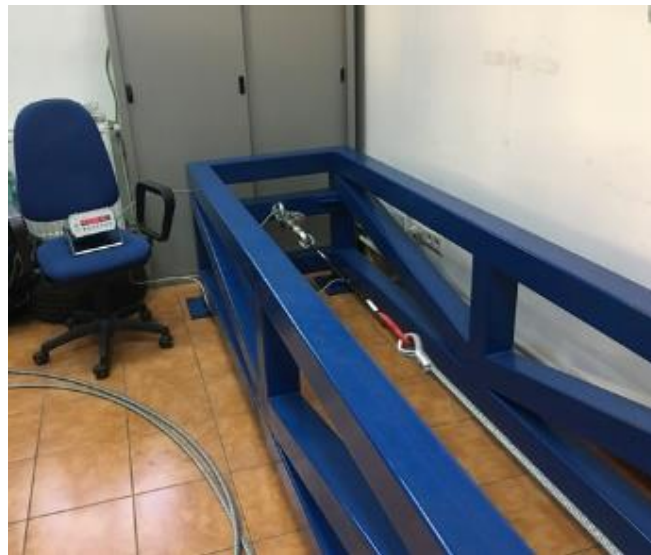
A set consisting of the 3 strap samples shown in Table 1 was prepared for each exposure. They were tested at a force of 15 kN for 3 minutes (see figure - 3) after being exposed to conditioning A followed by the

exposure to fire and contact heat. The static resistance of the unconditioned (initial) straps, exposed to fire and contact heat, was also tested.

**Figure 3 – Static resistance test stand**
